FLOOD PLAIN MANAGEMENT

**A Study Of South Fork
Shenandoah Tributaries**

**APPENDIX I
STONY RUN**

August 1983

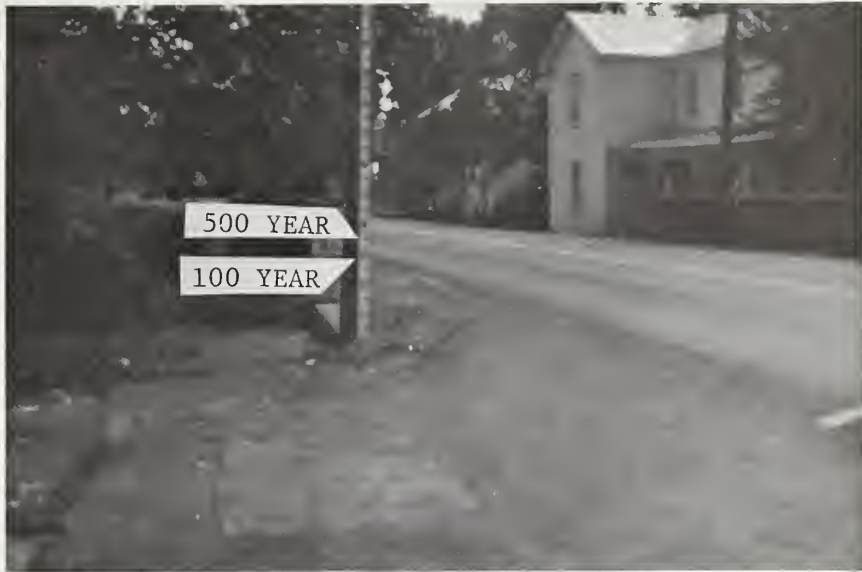
Figure 1. Looking east across Stony Run in McGaheysville, Virginia at State Route 996 (old US Highway 33).

Extreme floods would inundate about 127 acres of primarily agricultural land (see Table below). Extensive damage would be done to the land, crops, fences, farm roads, buildings and machinery. Less extensive but more critical damage would accrue to dwellings and businesses. Velocities would average about five feet per second and exceed seven feet per second in some reaches. Out-of-bank stages would range from about two to ten feet. Duration of flooding would seldom exceed six hours except during storms of intense and prolonged rainfall. Figure 1 and Figure 2 show potential flood stages at McGaheysville and at a bridge downstream.

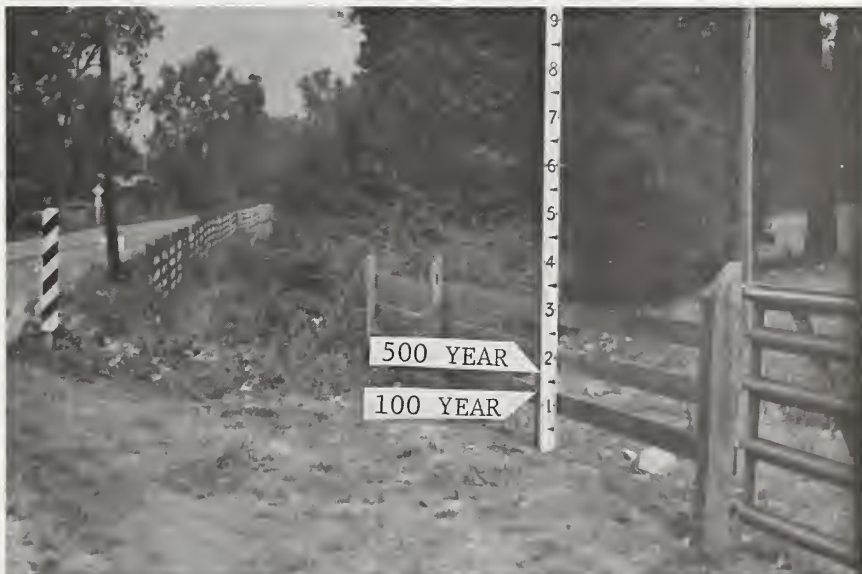
Figure 2. Looking north, at State Route 649 crossing of Stony Run south of McGaheysville.

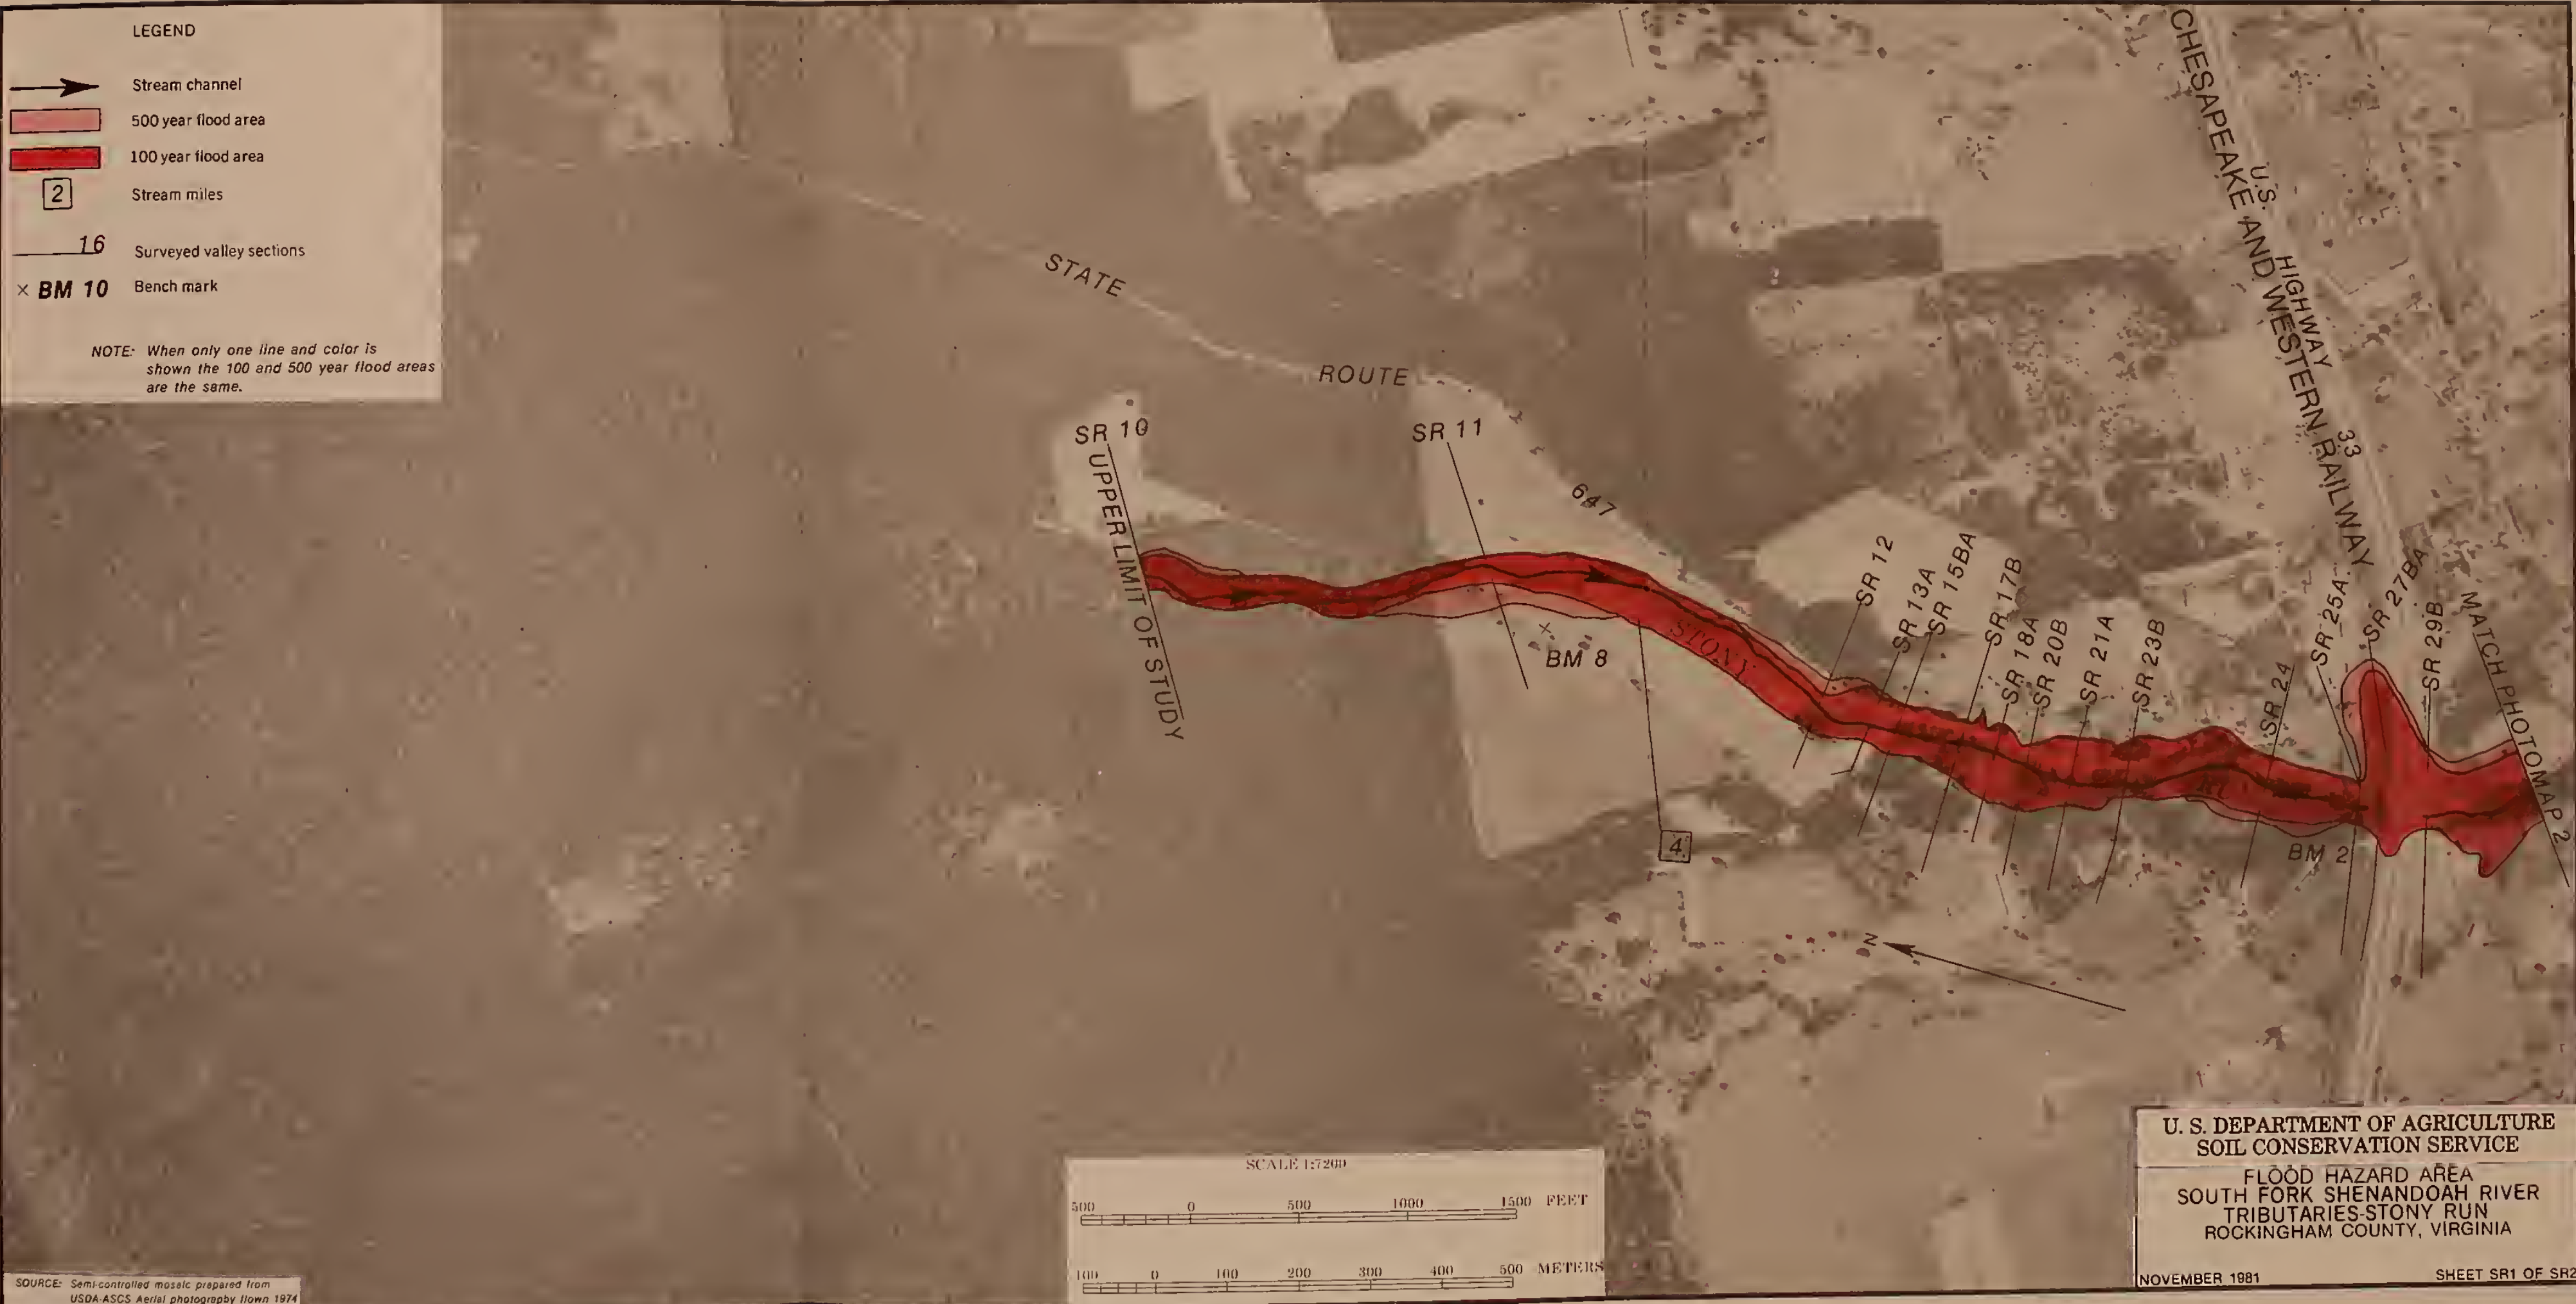
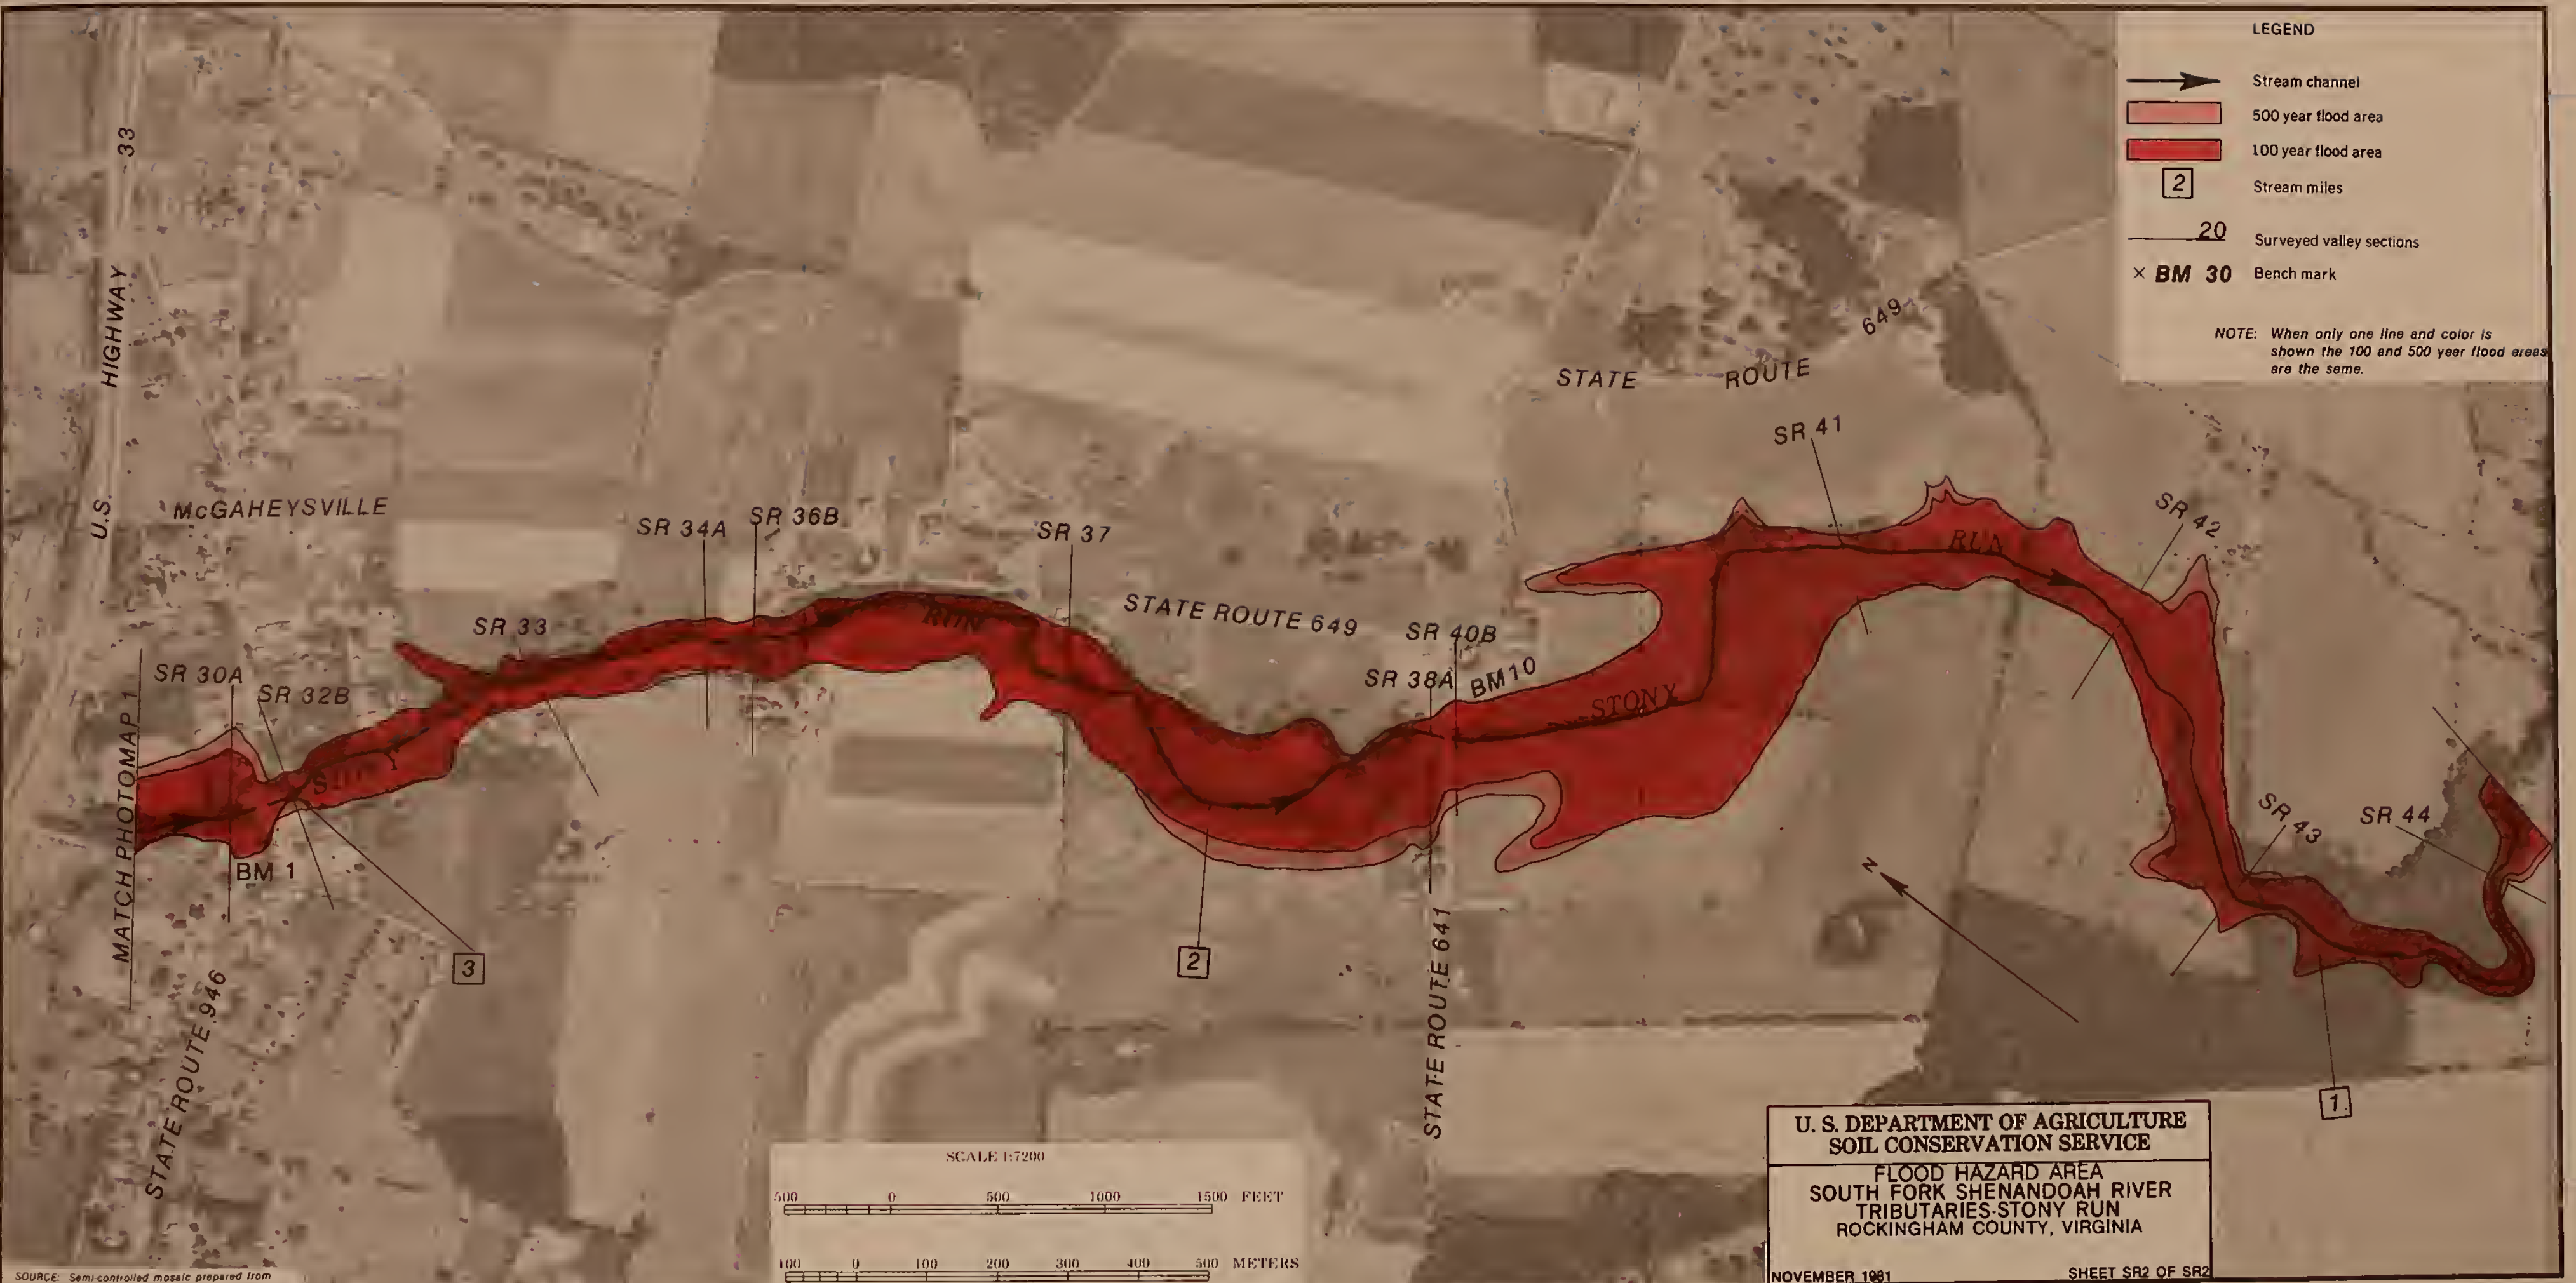
**FLOOD HAZARD AREA
SOUTH FORK SHENANDOAH RIVER
TRIBUTARIES-STONY RUN
ROCKINGHAM COUNTY, VIRGINIA**

The index map shows the area covered by the individual photomaps. Flood hazard photomaps show the area inundated by the 100 and 500-year floods. Where only one line is shown, there is no significant difference in the boundaries of the two flood areas. These photomaps should only be used to determine approximate flood elevations; they are based on semicontrolled mosaics and the boundaries shown may vary from the location on the ground.

1. On the appropriate photomap find the point on the stream where the flood line is to be located; then scale the distance along the stream to the nearest cross section.
2. On the appropriate flood profile sheet, scale the distance determined in Step 1 from the cross section back to the original stream location, and read the elevation of the desired flood frequency line.
3. Transfer the elevation determined in Step 2 to the ground from the nearest established benchmark.
